INDOOR AIR QUALITY ASSESSMENT

**Hatfield Town Hall
59 Main Street
Hatfield, Massachusetts**

Prepared by:
Massachusetts Department of Public Health
Bureau of Environmental Health Assessment
Emergency Response/Indoor Air Quality Program
June 2003

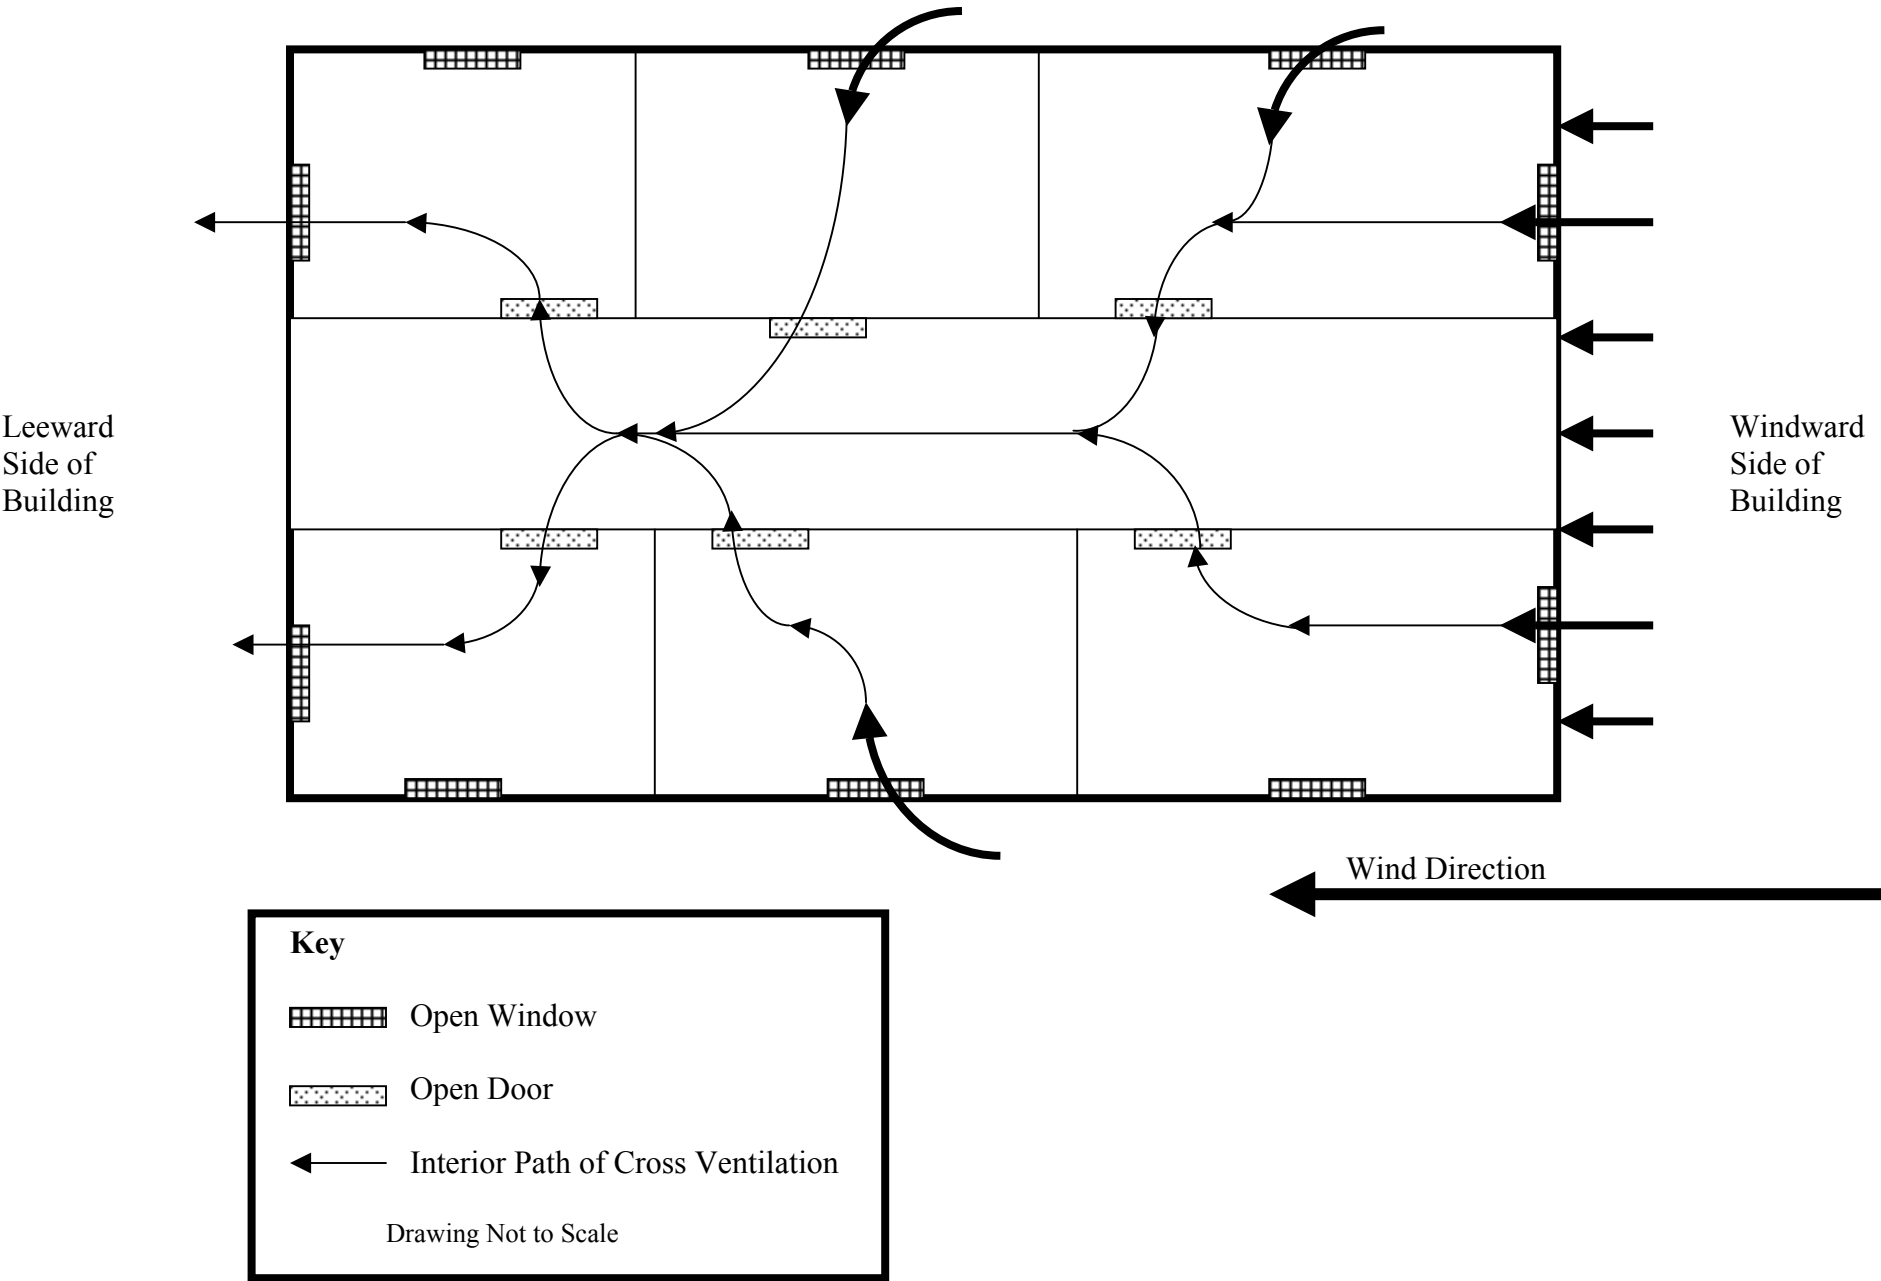
Figure 1

Cross Ventilation in a Building Using Open Windows and Doors

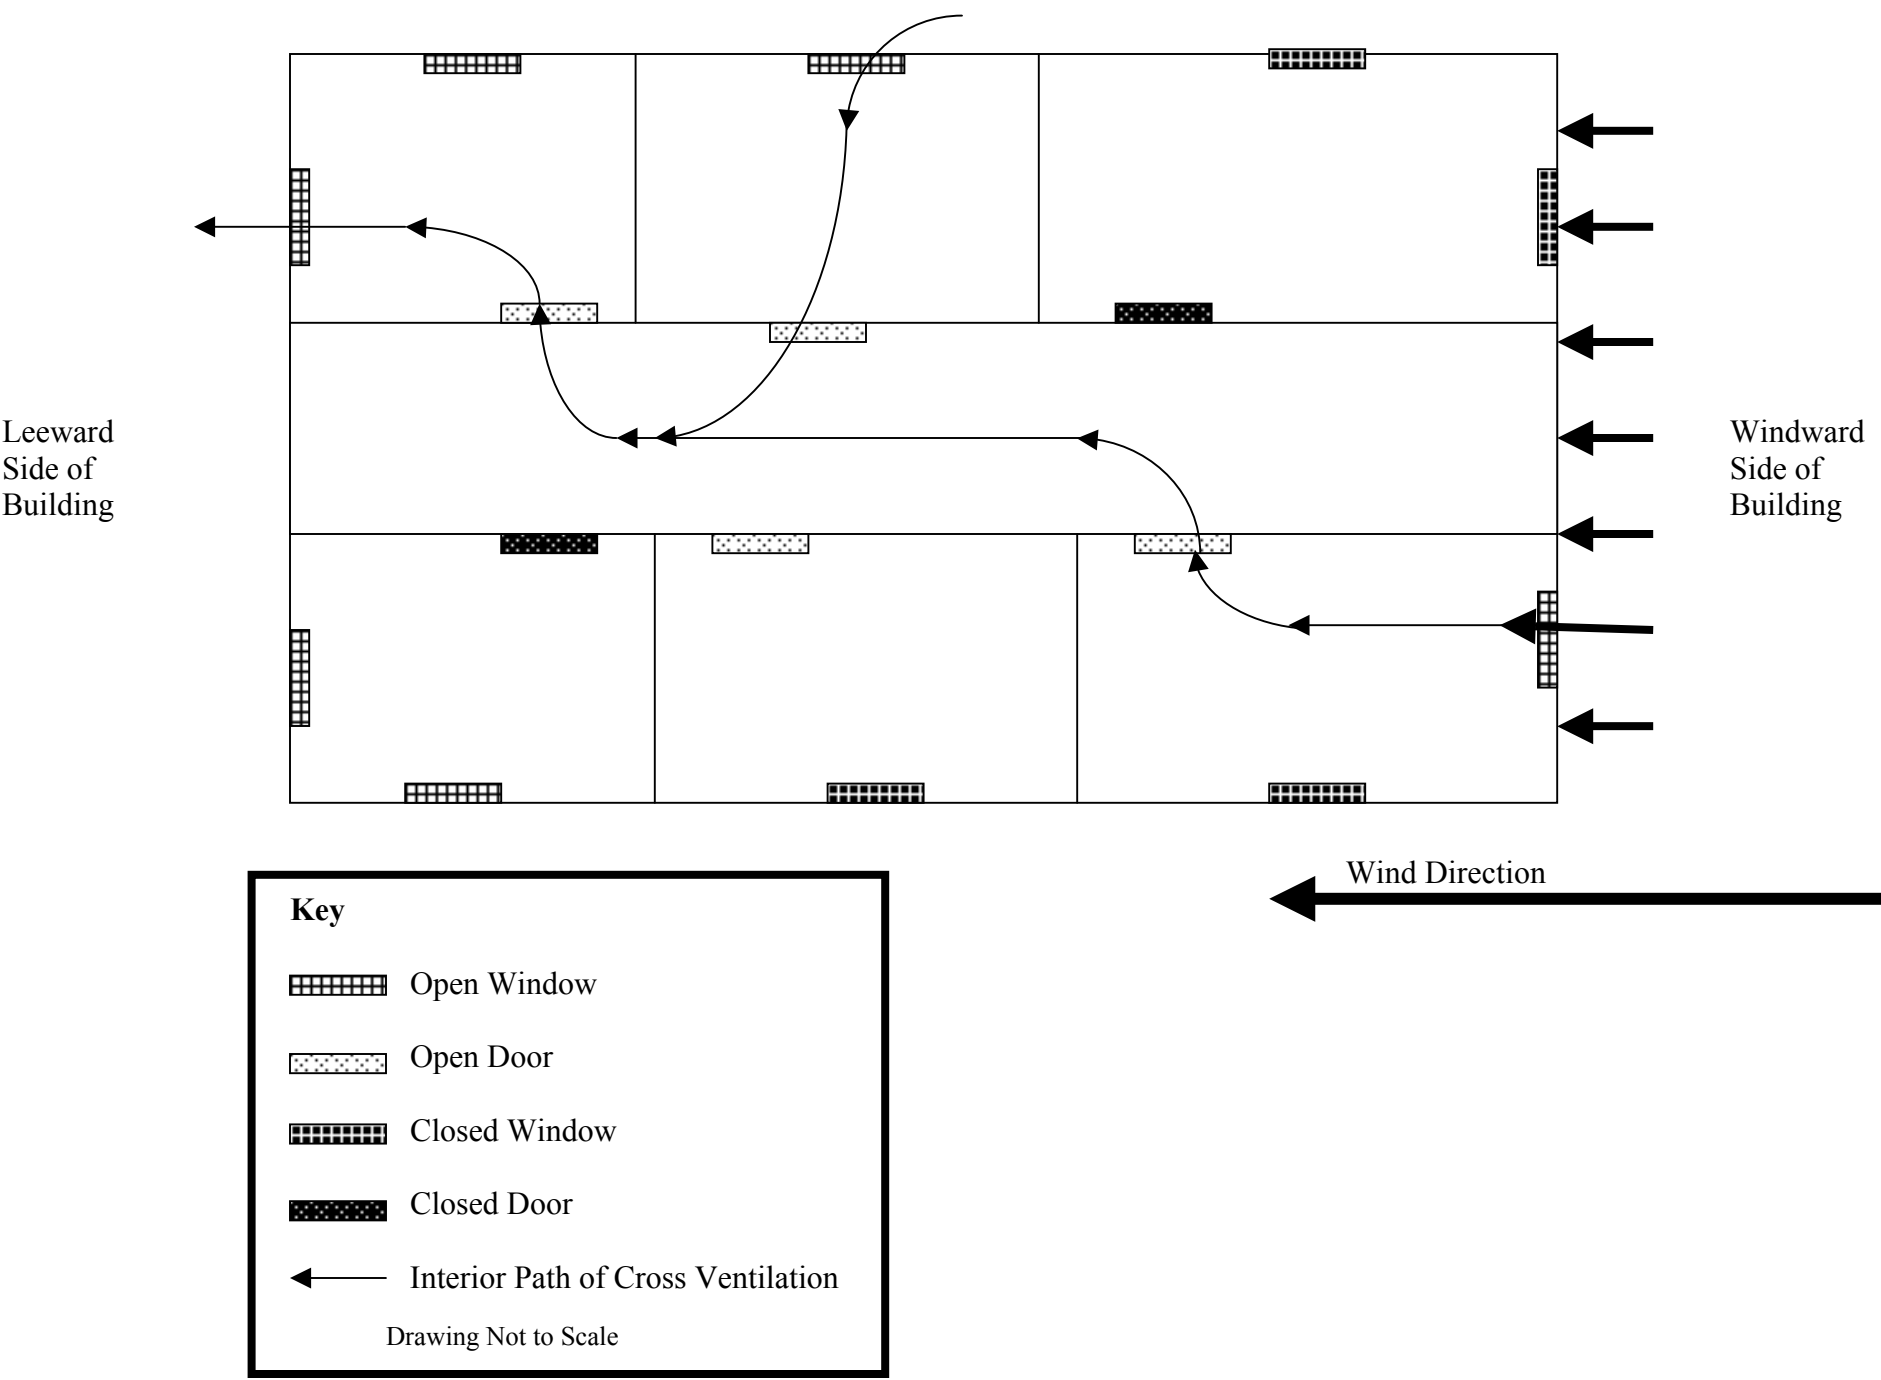
Figure 2

During summer months, ventilation in the town hall is controlled by the use of openable windows. The town hall was configured in a manner that uses cross-ventilation to provide comfort for building occupants. The building is equipped with windows on opposing exterior walls. This design allows for airflow to enter an open window (windward side), pass through a room, pass through the open door, enter the hallway, pass through the opposing open room door, into the opposing room and exit the building on the leeward side (opposite the windward side) (see Figure 1). With all windows and doors open, airflow can be maintained in a building regardless of the direction of the wind. This system fails if the windows or doors are closed (see Figure 2).

Inhibition of Cross Ventilation in a Building with Several Windows and Doors Closed

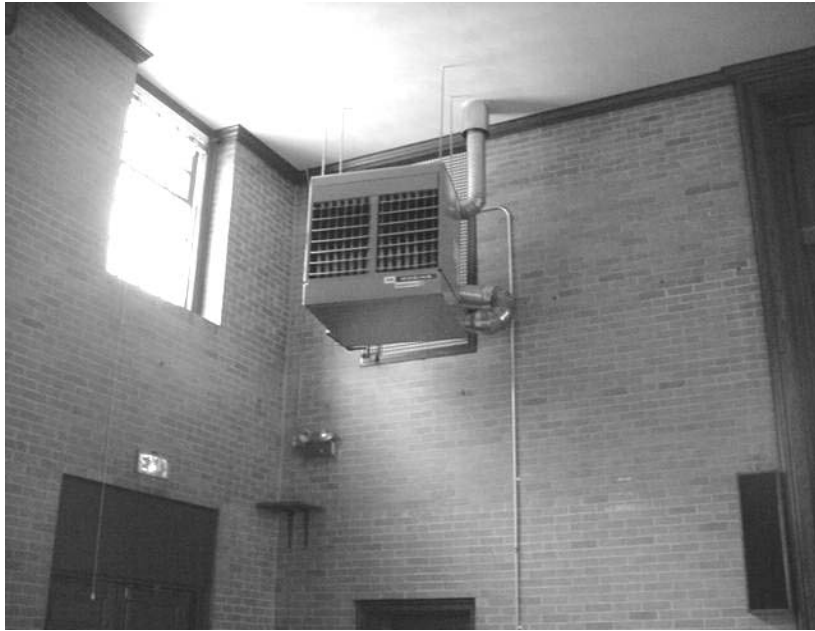
Picture 1

Auditorium Ventilation System

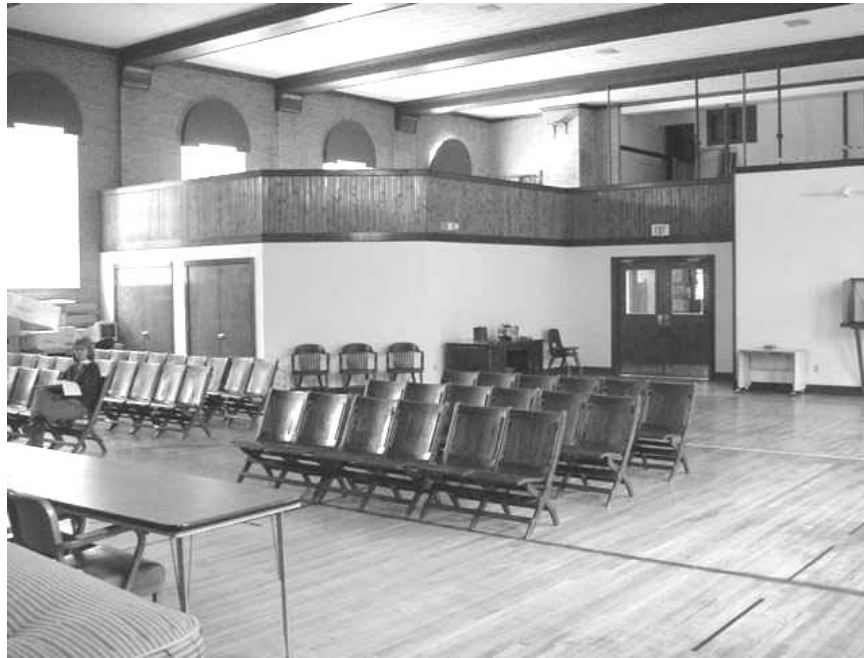
Picture 2

Some offices on the first floor were created by erecting walls beneath the second floor balcony of the auditorium (see Picture 2). These offices have neither a mechanical ventilation system nor windows. Instead, holes were cut into the floor of the balcony and passive vents were inserted for passive ventilation.

Offices Created below Auditorium Balcony

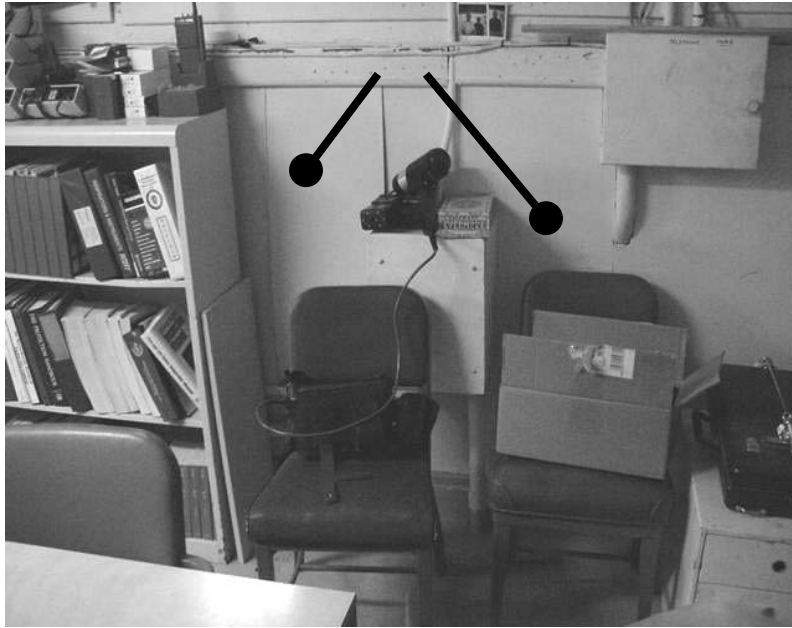
Picture 3

- Breaches in the foundation: Large penetrations were noted in the foundation wall (see Picture 3) and floor (see Picture 4) in the Fire Department office. These breaches can serve as sources for water entry. In addition, termites had infested wooden baseboards in contact with the floor of the Fire Department (see Picture 5). Termites generally will infest wood that is chronically moistened.
- Location of plant growth: Shrubbery was noted to be in direct contact with the exterior wall brick along the front of the building (see Picture 6). Plants retain water. Shrubbery can serve as a possible source of water impingement on the exterior curtain wall. In some cases, plants can work their way into mortar and brickwork causing cracks and fissures. This may subsequently lead to water penetration and possible mold growth.

Panel Covering Holes in Foundation Wall in Fire Department Office

- 7) Render all holes in the foundation walls airtight.
- 8) To prevent moisture penetration into the basement, the following actions should be considered:

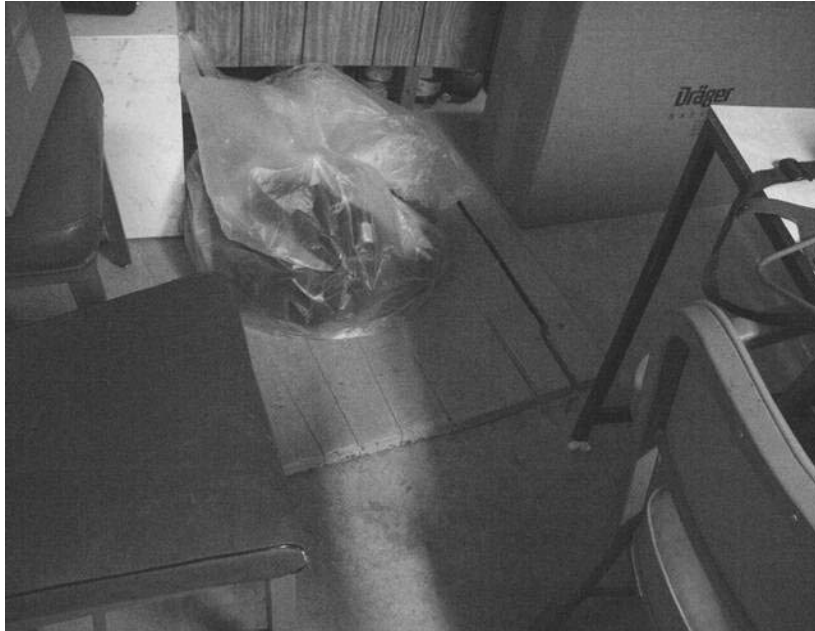
Picture 4

Wood Plug Covering Hole in Foundation Floor in Fire Department Office

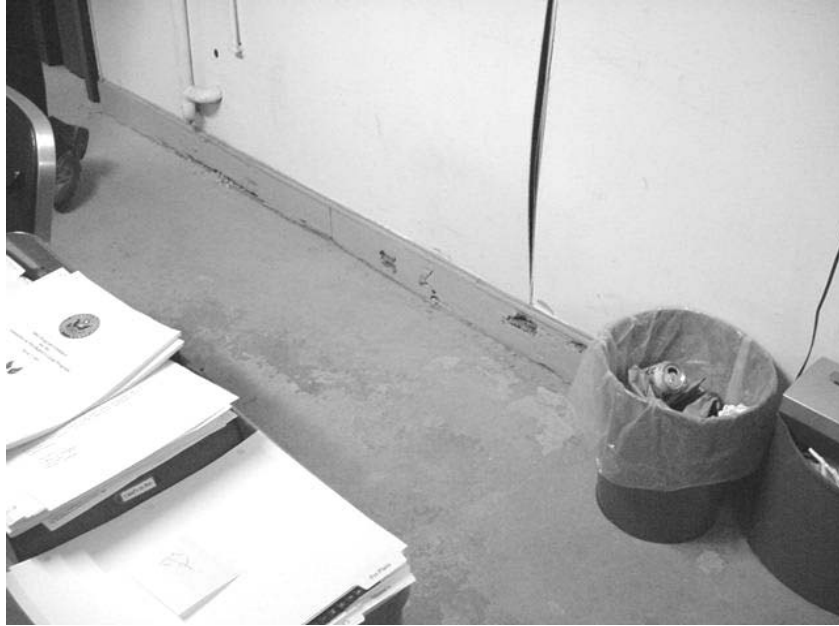
Picture 5

Termite Infested Baseboard in Fire Department Office

- 9) Remove mold colonized/termite infested materials from the basement. Disinfect non-porous surfaces with an appropriate antimicrobial.
- 10) For buildings in New England, periods of low relative humidity during the winter are often unavoidable. Therefore, scrupulous cleaning practices should be adopted to minimize common indoor air contaminants whose irritant effects can be enhanced when the relative humidity is low. To control for dusts, a high efficiency particulate arrestance (HEPA) filter equipped vacuum cleaner in conjunction with wet wiping of all surfaces is recommended. Avoid the use of feather dusters. Drinking water during the day can help ease some symptoms associated with a dry environment (throat and sinus irritations).

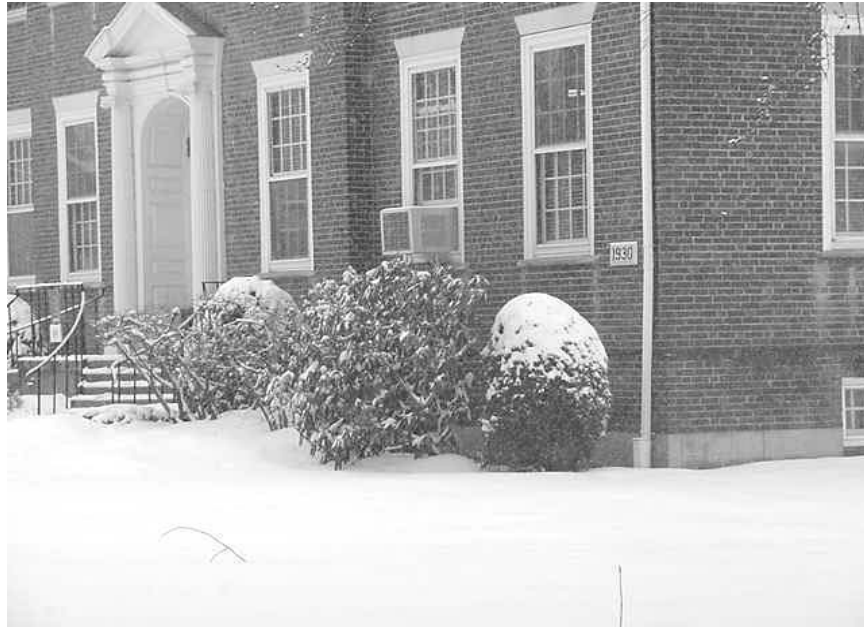
Picture 6

Shrubbery in Direct Contact with the Exterior Wall Brick along the Front of the Building

- a) Remove foliage to no less than five feet from the foundation.
 - b) Improve the grading of the ground away from the foundation at a rate of 6 inches per every 10 feet (Lstiburek and Brennan, 2001).

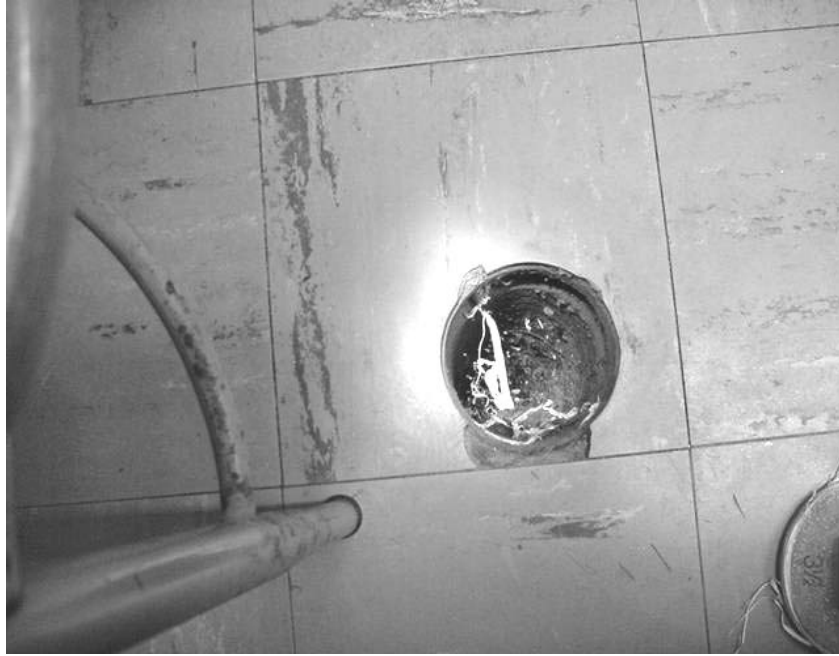
Picture 7

Floor drains and infrequently used sinks in the basement are another potential source of odors. Basement drains did not appear to have recently drained water, which can lead to dry traps. In one area, the floor had drains that were sealed, but were not rendered airtight (see Picture 7). An open drain exists in the fire department office (see Picture 8). A trap forms an airtight seal when water is poured down the drain. A dry

trap can allow for sewer gas to back up into the building. If the drain system were placed under positive air pressure (e.g. heavy rain), odors can be forced up through drains with dry traps. Sewer gas can be irritating to the eyes, nose and throat. Town officials checked with the wastewater treatment facility personnel, who reported no unusual discharges into sewer lines.

Capped, but Not Sealed, Drain In Basement

- 1) Contact the BEHA at 617 624-5757 if the odors/symptoms reappear.
- 2) Ensure that adequate temporary ventilation is used during any building maintenance (e.g. plumbing, painting).
- 3) Seal all abandoned drains in the basement.
- 4) Pour water into all drains in the building twice a week to wet traps.

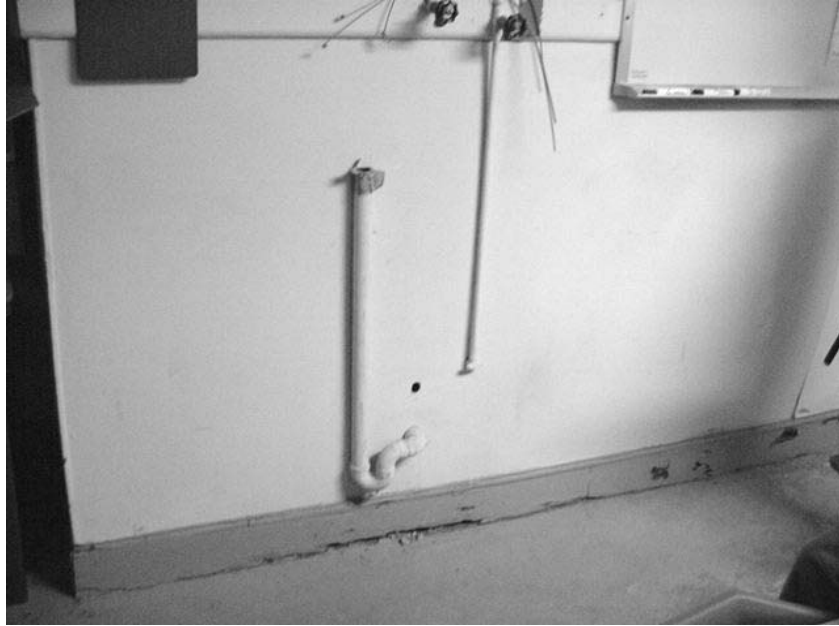
Picture 8

Open Drain in Fire Department Office

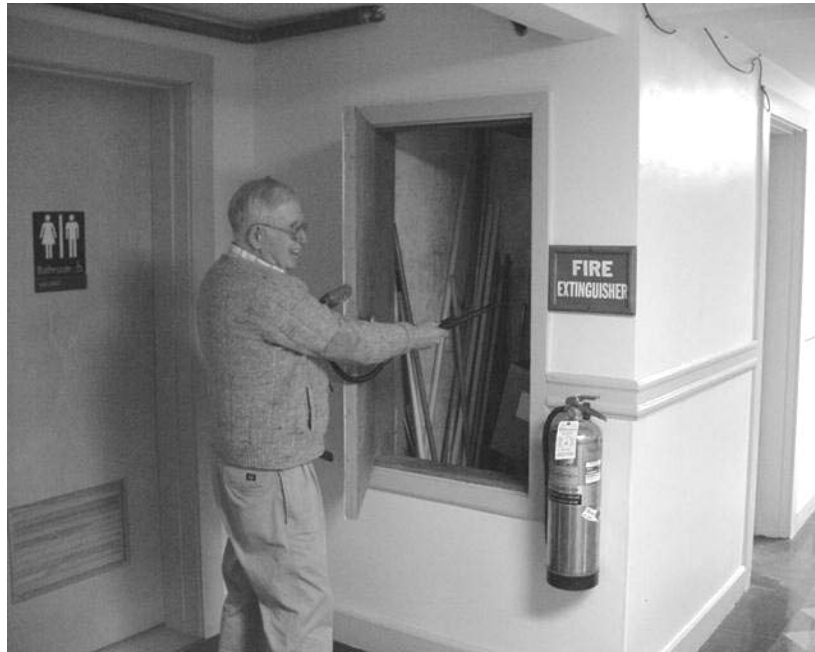
Picture 9

Each of these concepts can influence the movement of odors from the basement to the upper floors. The initial area where odors were reported was near the stairwell in the basement. Airflow from this area would be in an upward movement, up the stairwells and/or the abandoned dumbwaiter (see Pictures 9 and 10).

Abandoned Dumbwaiter, Basement

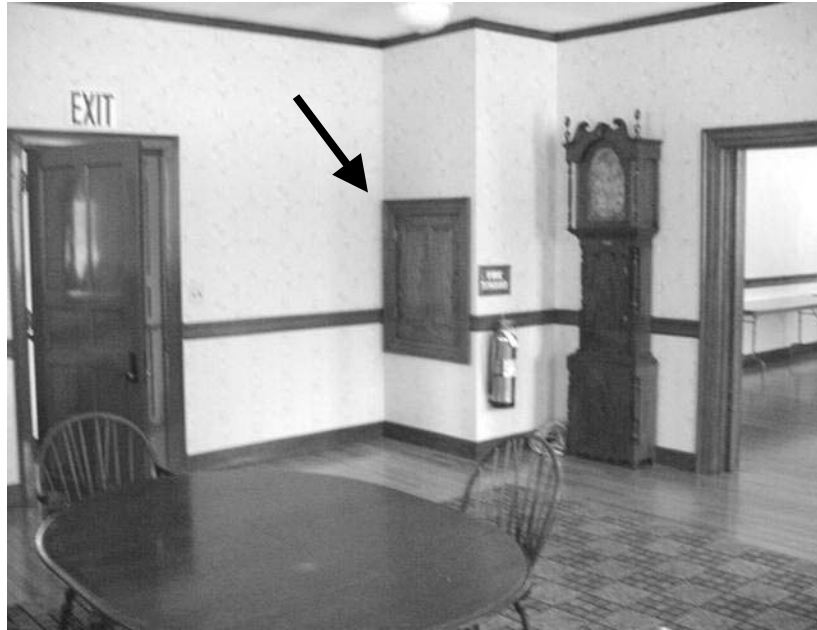
Picture 10

Abandoned Dumbwaiter, Second Floor
